Bat Survey

Northern United

November 2017

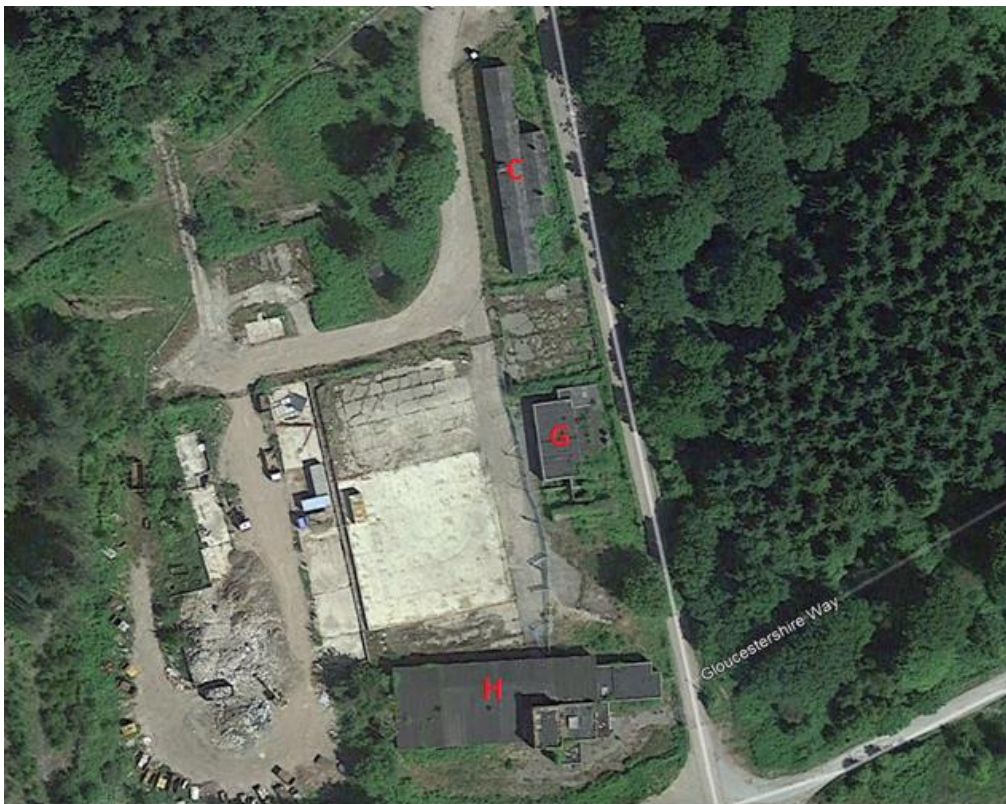
- 2.2 Three buildings remain on the northern united site, the Office (Building C), Canteen (Building G) and Bath House (Building H), which all have historical records of bats present, notably Lesser Horseshoe bats. the proposals for the site will result in the demolition of all three buildings and loss of all bat roosts present. See Figure 1

Figure 1: Showing the three buildings on the site subject to survey.

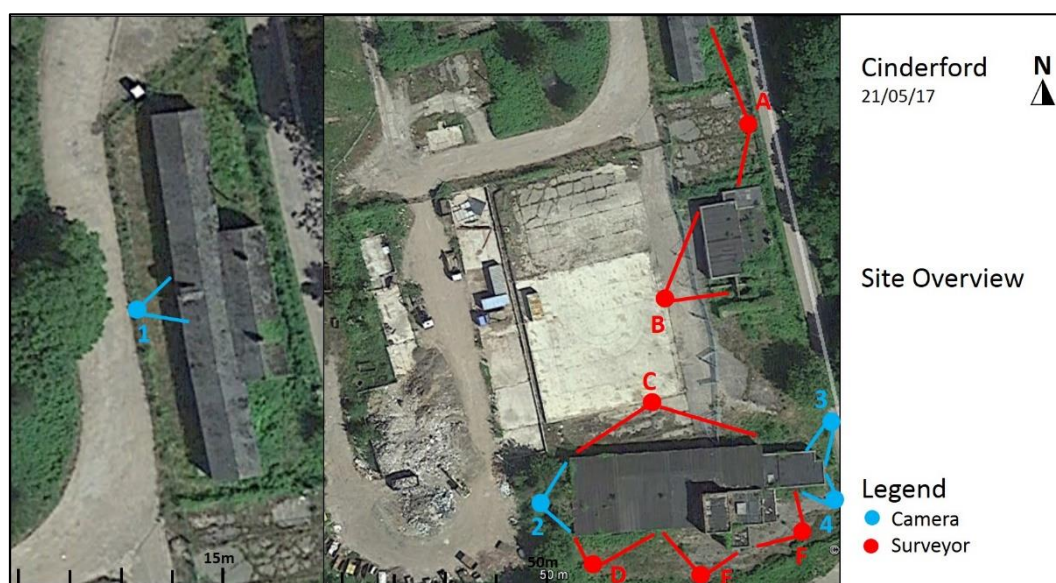
- 4.1 **21st May** - Weather conditions were good for the survey (18°C with 60% cloud cover and a moderate breeze at 21:26) and any bats present were likely to be active. Six surveyors and four night vision cameras monitored the Office, Canteen and Bathhouse.

Figure 1: Showing positions of surveyors and cameras around the Office (left), Canteen and Bathhouse (right) on 21st May.

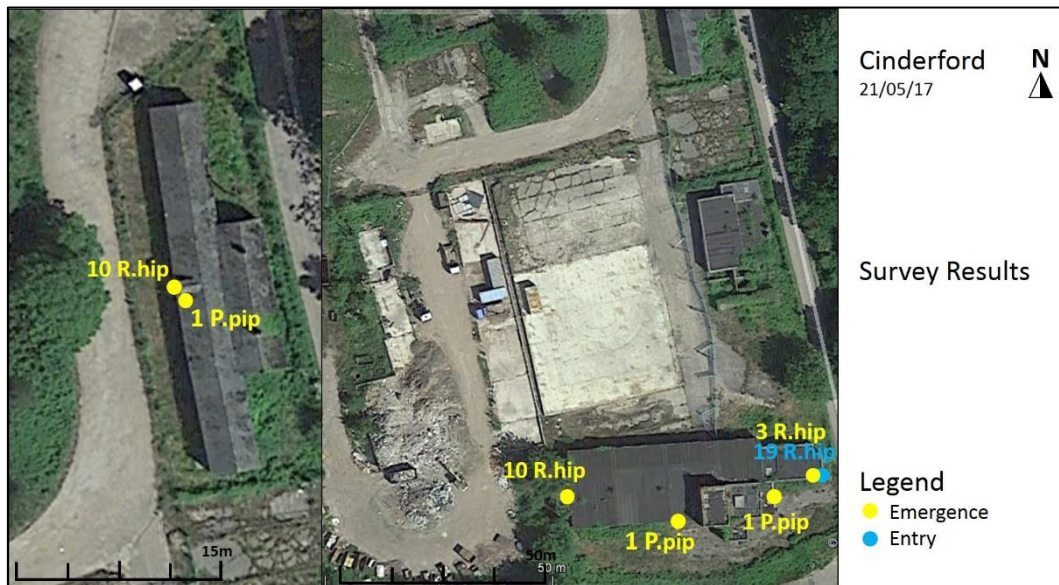
- 4.2 The survey identified a good level of foraging activity of common and soprano pipistrelle and lesser horseshoe, with passes of noctule and a myotis species also recorded, and a single greater horseshoe. Lesser horseshoes were identified emerging from and re-entering known emergence points: the porthole window on the western elevation of the office building, the two small windows on the south-east corner of the Bathhouse and the three windows on the western elevation of the Bathhouse. Aside from this, one common pipistrelle emerged from the southern side of the dormer window on the west elevation of the Office, and two common pipistrelles were identified emerging from the southern elevation of the Bathhouse: one from the flat roof just west of the tower, the other from the east-facing door to the east of the tower. Full results are detailed in Table A1 in the Appendix.

Figure 2: Showing emerging and re-entering bats recorded during the 21st May survey.

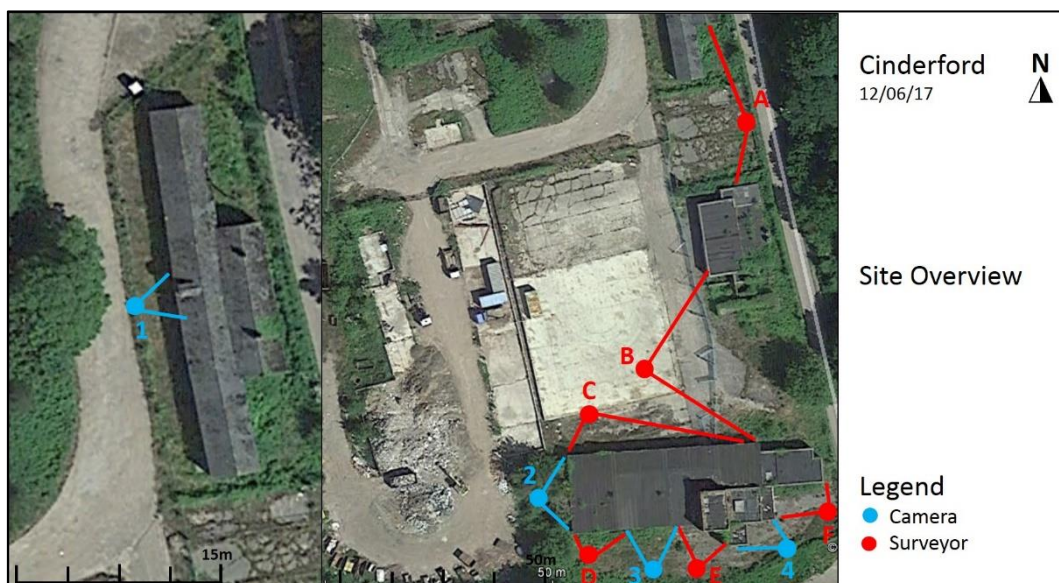
- 4.3 **12th June** - Weather conditions were good for the survey (14°C, clear and calm at 21:28) and any bats present were likely to be active. Six surveyors and four night vision cameras monitored the Office, Canteen and Bathhouse.

Figure 3: Showing positions of surveyors and cameras around the Office (left), Canteen and Bathhouse (right) on 12th June.

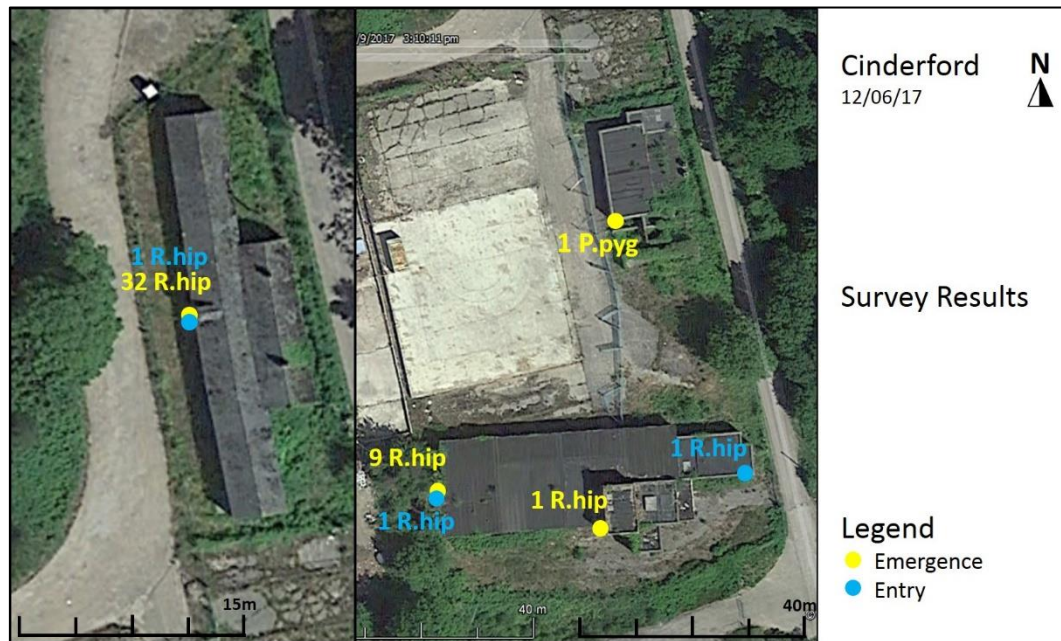
- 4.4 The survey identified a moderate level of foraging activity of common and soprano pipistrelle and lesser horseshoe, with a single noctule and long-eared bat pass recorded. Lesser horseshoes were identified emerging from and re-entering known emergence points: the porthole window on the western elevation of the office building, the two small windows on the south-east corner of the Bathhouse and the three windows on the western elevation of the Bathhouse. One soprano pipistrelle was identified emerging from the south-western corner of the Canteen building. Full results are detailed in Table A2 in the Appendix.

Figure 4: Showing emerging and re-entering bats recorded during the 12th June survey.

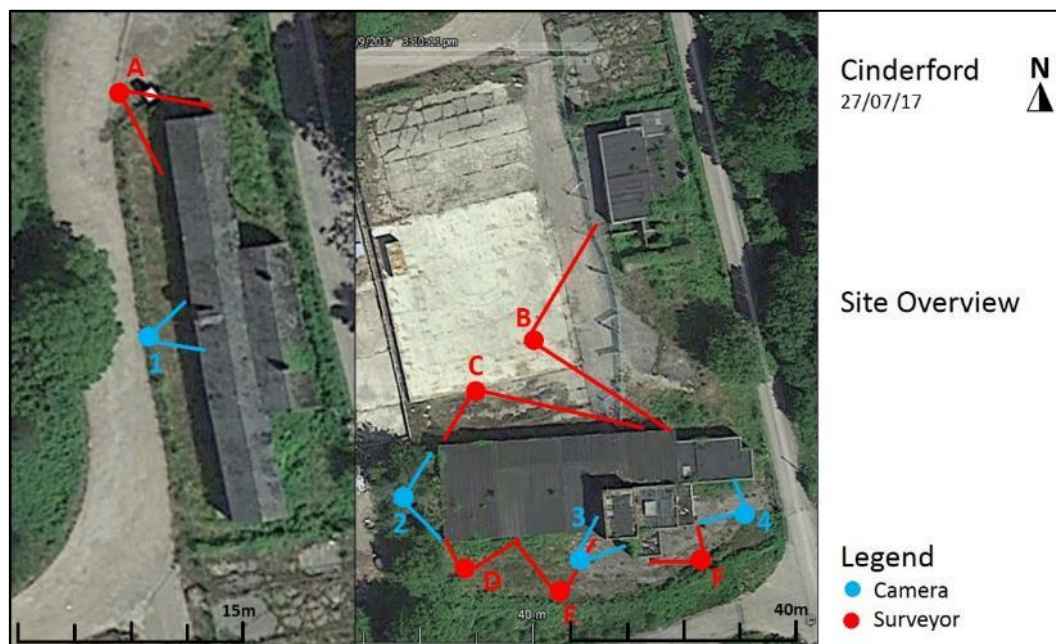
- 4.5 **27th July** - Weather conditions were good for the survey (16°C with 75% cloud cover and a moderate breeze at 21:08) and any bats present were likely to be active. Six surveyors and four night vision cameras monitored the Office, Canteen and Bathhouse.

Figure 5: Showing positions of surveyors and cameras around the Office (left), Canteen and Bathhouse (right) on 27th July.

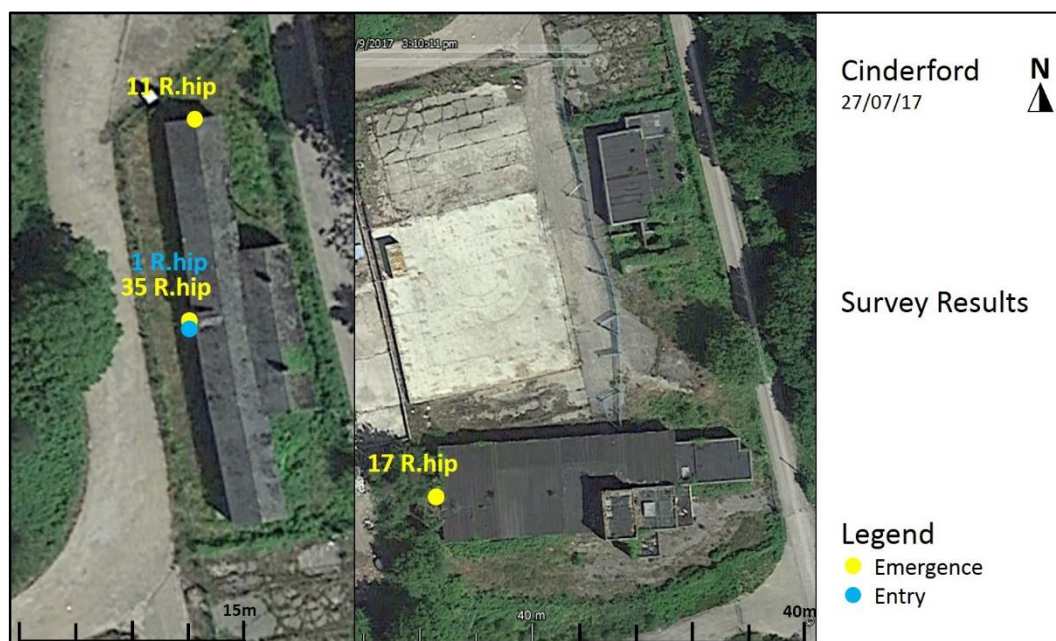
- 4.6 The survey identified a moderate level of foraging activity of common and soprano pipistrelle and lesser horseshoe, with passes of noctule, long-eared bat and a myotis species also recorded. Lesser horseshoes were identified emerging from and re-entering known emergence points: the porthole window on the western elevation and roller door on the northern elevation of the Office building, the two small windows on the south-east corner of the Bathhouse and the three windows on the western elevation of the Bathhouse. No species other than lesser horseshoe bat were observed or recorded emerging from the buildings on this survey. Full results are detailed in Table A3 in the Appendix.

Figure 6: Showing emerging and re-entering bats recorded during the 27th July survey.

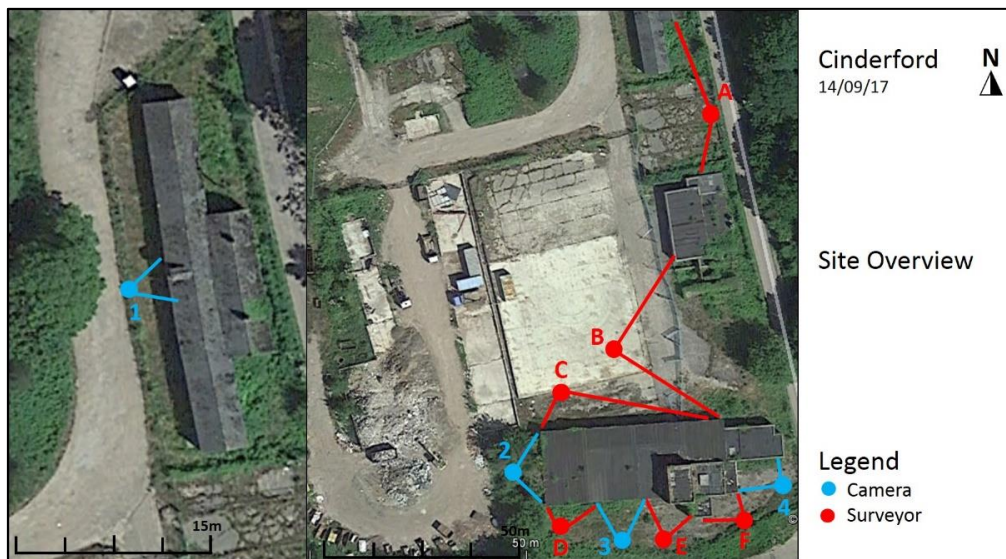
- 4.7 **14th September** - Weather conditions were okay for the survey (10°C and clear with a very slight breeze at 19:26) and any bats present were likely to be active. Six surveyors and four night vision cameras monitored the Office, Canteen and Bathhouse.

Figure 7: Showing positions of surveyors and cameras around the Office (left), Canteen and Bathhouse (right) on 14th September.
